# perfect scan = perfect fit

## Rejected Scans - Need to Rescan Patient

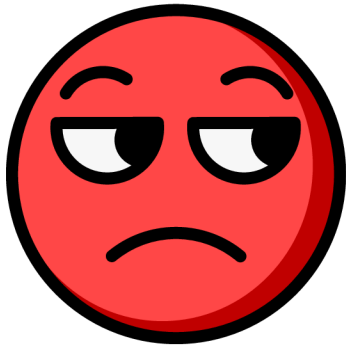
Lacks the complete palate and would not work for any acrylic appliance. **Cannot be fixed digitally.**

*This would be acceptable for Essix ONLY*

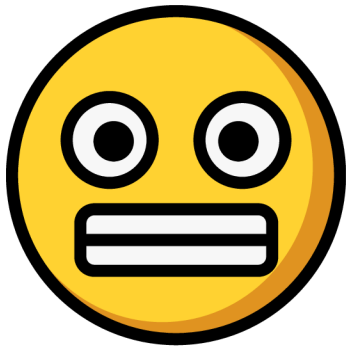
Contains enough palatal definition back into the area of the 2nd molars. However, the **lack of a complete palatal scan may require additional fees** depending on appliance design.

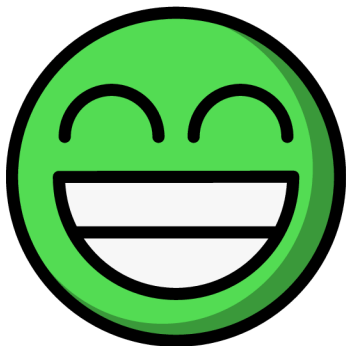
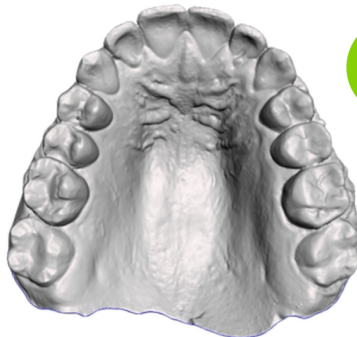
Perfect Scan to make ANY appliance. All teeth appear to be scanned completely without any distortions. All palatal areas are scanned and cover the complete area between the distal most teeth.
